IMPORTANT WARRANTY INFORMATION AVOID SEVERE ENGINE DAMAGE & PREMATURE INJECTOR FAILURE

This Technical Bulletin addresses common issues encountered when installing HEUI G2.9 Injectors for the Navistar/International DT466/570 application.

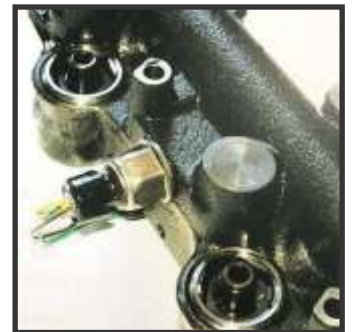
ICP Sensor Location

This issue is commonly a bad ICP Sensor. A vehicle with a bad ICP sensor will start with the sensor unplugged, and will not start with the sensor plugged in. The ICP sensor connector is the second connector from the rear of the valve cover gasket, hidden behind the crankcase vent. Severe high pressure oil leaks could be caused by damaged oil rail seals. These seals must be replaced every time injectors are removed and re-installed. Oil Rail Seal Kit GB P/N: 522-069. A torn seal can cause a misfire on one cylinder. Multiple bad seals can cause a No Start or Stalling issue.

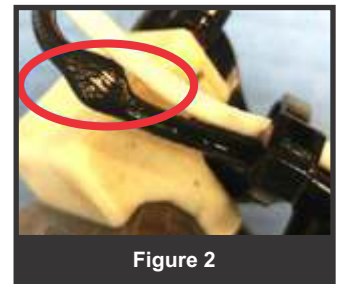
In engines with good compression, this type of failure is commonly caused by insufficient fuel supply pressure or debris entering the injector during the installation process. These injectors are highly susceptible to failure from debris, because there are no filter screens in the fuel inlet of the injector (Figure 1). Warranty analysis commonly reveals dirt and/or metal debris in the fuel side or oil side of the injector (Figure 2). Contamination from metal debris is common in cases where injectors were installed during an engine overhaul. Incorrect maintenance intervals/procedures of the fuel and oil systems can also allow debris to enter the injector and cause failures. Coil wires can be pinched during installation, also causing misfires (Figure 3).

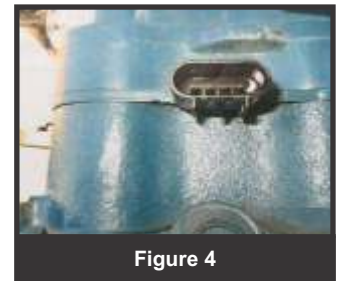
Injector harness failures are common in early applications. The valve cover gasket has integrated circuits for injectors and ICP sensor, and failures from "Oil Wicking" are common (Figure 4). Injector circuit codes and misfires under load are commonly caused by poor connections at the valve cover gasket. Use the latest design with improved electrical locks to avoid this issue. The harness connector in the early applications does not have a secondary lock, allowing it to lose continuity when the engine is torqued up in the chassis. Double check all connectors are secured. There is a TSI letter on an updated lock used on the later engines. TSI Number: 05-12-10 TSI Date: February 2005.

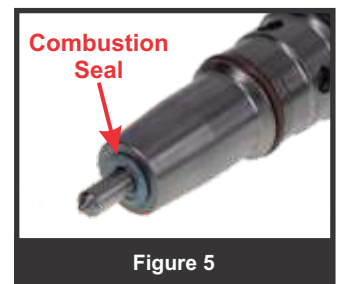
Leaking combustion seal: (Figure 5)

When replacing the injector the combustion seal must be replaced and is included with GB's remanufactured injector. In most cases the combustion seal will remain on the old injector when removed. Verify the seal is present on the injector being replaced, if it is not, inspect the injector bore for the seal and remove as necessary. Inspect the injector bore for damage, contamination and/or corrosion. Correct any defects with the injector bore prior to installing the new injector.

NOTICE: Failure to replace the combustion seal and properly torque the injector will result in injector failure and may cause severe engine damage. Failure as a result of these conditions is NOT covered by GB's limited warranty.

- Injector hold down clamp - 10 lbf-ft (13.6 Nm)
- High pressure oil rail/manifold screws - 20 lbf-ft (27 Nm)
