**AVOID SEVERE ENGINE DAMAGE • ALWAYS FOLLOW MANUFACTURER'S SERVICE PROCEDURES**

**GB Remanufacturing, Inc.**

TB-0106-E

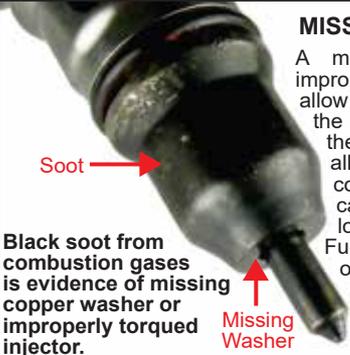
<p><b>MISSING COPPER WASHER</b></p> <p>A missing copper washer or improperly torqued injector can allow hot combustion gases into the injector cavity. This will cause the lower fuel o-ring to fail allowing fuel to enter the combustion chamber. This can cause hydrostatic engine lock-up and engine failure. Furthermore, hot gases can overheat the injector's internal components causing injector failure.</p> <p><b>Black soot from combustion gases is evidence of missing copper washer or improperly torqued injector.</b></p> <p><b>Soot</b> →</p> <p>→ <b>Missing Washer</b></p>

- Copper washer is present on injector being replaced.
- Copper washer is installed on replacement injector.
- Injector is properly torqued - see service manual.
- Engine oil is clean and at the proper level.
- Fuel supply is free from water, air and contamination.
- Fuel pressure is at manufacturer's specifications.
- Injector sleeve is clean and damage-free.
- Engine coolant shows no sign of engine oil (sleeve failure).
