IMPORTANT WARRANTY INFORMATION
AVOID SEVERE ENGINE DAMAGE & PREMATURE INJECTOR FAILURE

► **SPECIAL LB7 FUEL LINE INSPECTION PROCEDURE**

GB Remanufacturing, Inc.

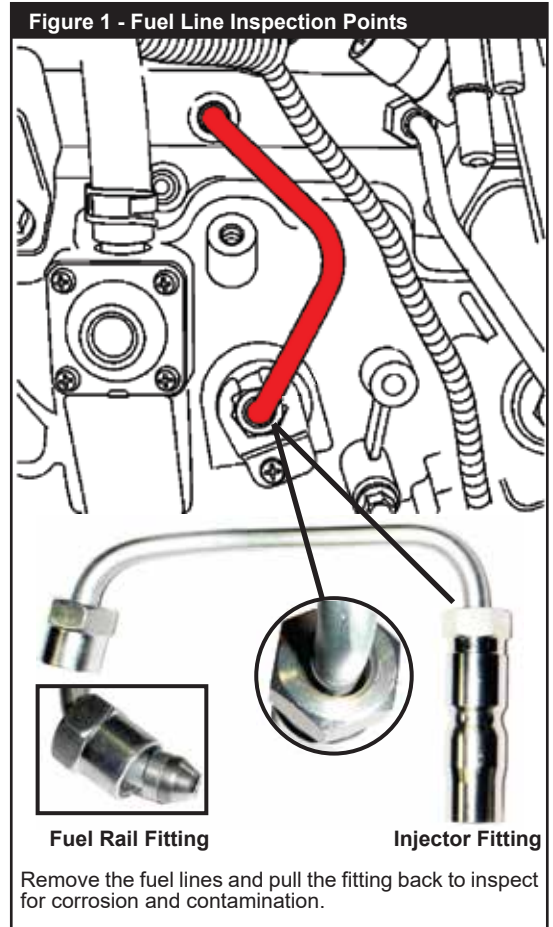
The unique design of the LB7 fuel lines that connect the high pressure rail to the injector are extremely susceptible to corrosion on the inside of the fitting that passes through the valve cover - see figure 1. Because it is exposed to underhood elements, the area between the tube and fitting can collect water and debris. Water corrodes the area between the tube and fitting and when removed the corrosion and debris is broken loose, which will enter the fuel supply inlet of the new injector.

Because the fuel line is down stream from the fuel filter on the high pressure side, the contamination enters the injector and can cause premature failure of the new injector.

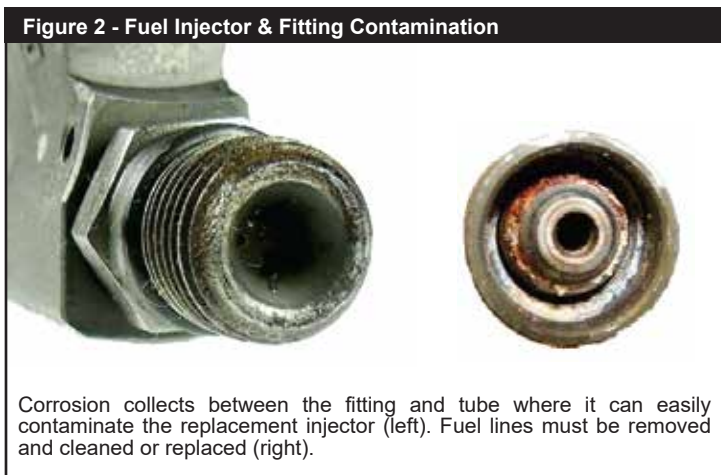
When replacing the fuel injectors, all fuel lines should be completely removed, inspected and cleaned or replaced. **Figure 2** shows a typical corrosion condition for the fitting on the fuel line that connects to the injector.

Injector Fuel Line Part Numbers	
Cylinders 1 & 8	GB P/N 7-005
Cylinders 2 & 7	GB P/N 7-006
Cylinders 3 & 6	GB P/N 7-007
Cylinders 4 & 5	GB P/N 7-008

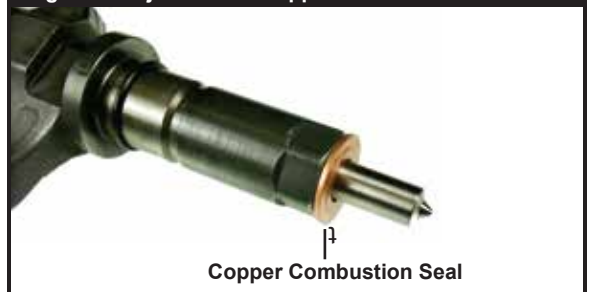
Figure 3 - Injector with Copper Combustion Seal

Failure to install the copper combustion seal or an improperly torqued injector can result in injector failure and engine damage. The copper combustion seal is included with GB's remanufactured injectors. (**See Figure 3.**)

- Ensure the copper combustion seal is present on the injector being replaced. If the seal is missing inspect the injector bore for seal and remove prior to installing replacement injector.
- If the injector being replaced shows signs of combustion seal leakage (**Figure 4**) and the prior injector is missing the copper seal it will be necessary to replace the injector sleeve prior to installing the replacement injector. Failure to do so will result in leakage of the new combustion seal and injector failure. To clean light carbon build-up from injector bore use GM special tool EN-47909 and refer to GM TSB 05-06-04-067.
- Always inspect the injector bore for corrosion, damage or leakage prior to installing new injector.
- Ensure injector is torqued to manufacturer's specification.
