**IMPORTANT WARRANTY INFORMATION**  
**AVOID SEVERE ENGINE DAMAGE & PREMATURE INJECTOR FAILURE**

**GB Remanufacturing, Inc.**

TB-0110B-E

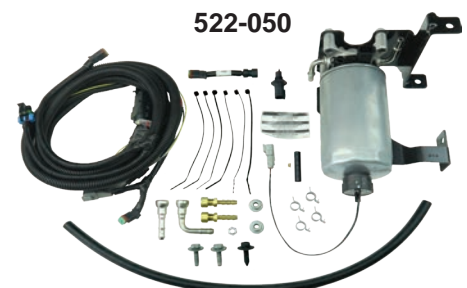
GB has released an OE recommended severe duty fuel filter upgrade kit for the Dodge Cummins 5.9L and 6.7L. Contamination is the number one cause of failure on Dodge common rail systems. The original equipment filtration system is inadequate in removing common contaminants, resulting in premature injector failure. Injector failure due to contamination is not covered under GB's limited warranty. This new kit includes an upgraded fuel filter and housing, wiring harness, fuel lines, fuel heater and water-in-fuel sensor (used on 5.9L only).

Injector failure as a result of any of these conditions is not covered by GB's limited warranty.

Year	Application	GB P/N	Replacement Filter
2004.5-09	Dodge Cummins 5.9L Pickup	522-050	522-056
2007-12	Dodge Cummins 6.7L Pickup		
2007-12	Dodge Cummins Cab & Chassis 6.7L	522-049

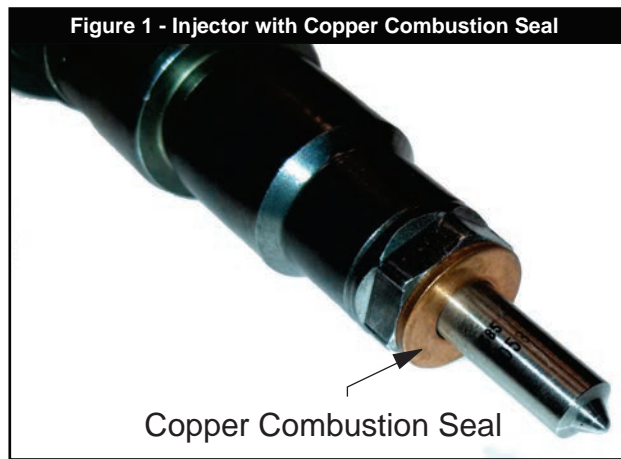
Failure to install the copper combustion seal or an improperly torqued injector can result in injector failure and engine damage. The copper combustion seal is included with GB's remanufactured injectors. See figure 1.

An injector installed without the copper combustion seal will result in hot combustion gases heating the injector's lower section, resulting in premature failure. If combustion gas leakage is present the injector sleeve must be replaced.

- Ensure the copper combustion seal is present on the injector being replaced. If the seal is missing inspect the injector bore for seal and remove prior to installing replacement injector.
- If the injector being replaced shows signs of combustion seal leakage and the prior injector is missing the copper seal it will be necessary to replace the injector sleeve prior to installing the replacement injector. Failure to do so will result in leakage of the new combustion seal and injector failure.
- Always inspect the injector bore for corrosion, damage or leakage prior to installing new injector.
- Ensure injector is torqued to manufacturer's specification.
