INTRODUCTION TO TECHNICAL SERVICE BULELTINS (TSB'S)

TB-0112-E

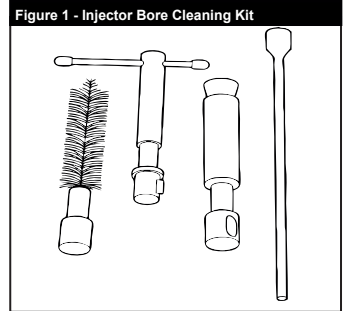
TSB 05-06-04-067: The injector bores on the 6.6L Duramax engine can gather buildup of carbon deposits, GM has recognized this and provides a cleaning kit along with a procedure for the repair. See GM part number: EN-47909. It is essential to perform this procedure at the time of injector replacement in order to avoid contamination of new injectors. **(SEE FIGURE 1)**

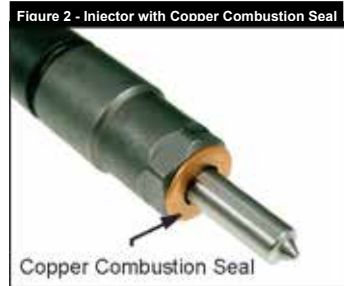
COPPER GASKET (FIGURE 2)

When replacing the injector the copper combustion seal must be replaced and is included with GB's remanufactured injector. In most cases the copper combustion seal will remain on the old injector when removed. Verify the copper seal is present on the injector being replaced, if it is not, inspect the injector bore for the seal and remove as necessary. Inspect the injector bore for damage, contamination and or corrosion. Correct any defects with the injector bore prior to installing the new injector.

NOTICE: Failure to replace the copper seal and properly torque the injector will result in injector failure and may cause severe engine damage. Failure as a result of these conditions is NOT covered by GB's limited warranty.
